Company medifa hygienic rooms GmbH Mr Stockmar Heinrich-Hertz-Str. 4 76470 Ötigheim

Investigative report on the airtightness measurement of an operating room

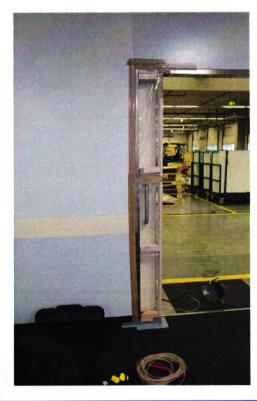
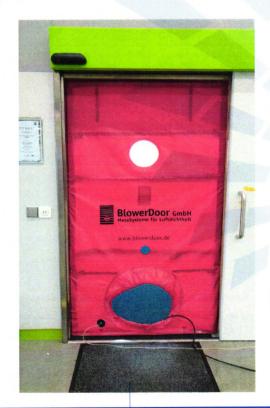
The frame component required for the pressure test was installed in the provisionally reduced door opening of the object (showroom), into which the fan was inserted.

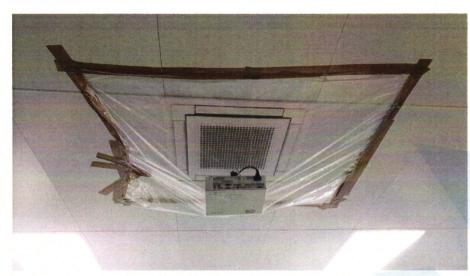
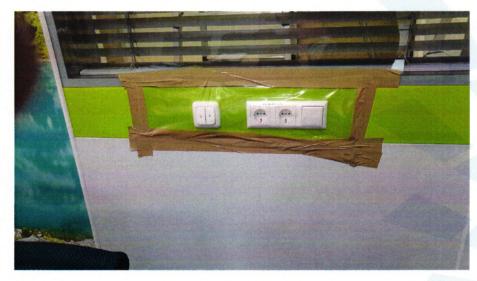
The air conditioning and ventilation module was then provisionally masked on the ceiling and the recessed sockets for the electrical supply and the push-buttons on the wall.

This was necessary in the case at hand as only the wall and ceiling elements and their connection joints were the subject of the airtightness measurement. The floor as another space-limiting component surface could be regarded as airtight due to the existing closed covering (without ducts).
