Test Report

Document number: (1101/505/18) - short – Bod of 06/06/2018

Subject of the order: Testing a wall of 3.50 m x 3.60 m, type MediFa, Bending strength and fall protection pursuant to DIN 4103-1 and with reference to ETAG 003

Test basis: DIN 4103-1:2015, DIN 18183-1:2018
ETAG 003:2013

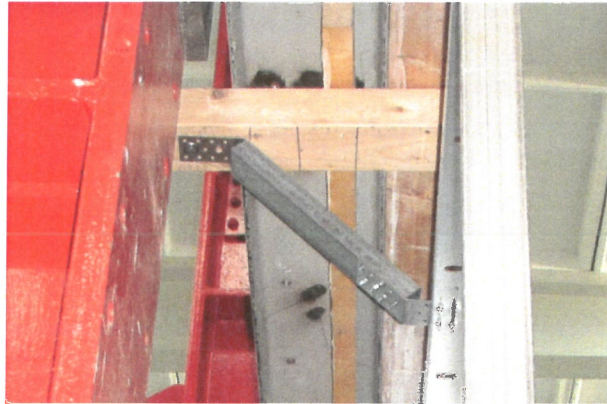
Image 1: Tension and compression-resistant assembly of the wall at the upper edge, using two angles and a steel section attached to the cross strut of the test stand

At the top edge, the wall was not fastened directly to the upper wooden plank (# 16/16). The upper transverse U-shaped rail (H101-0001-01, 60x30x2) was mounted using three suspending brackets at an angle of 45° (H101-0001-01, 60x30x2). These three angled suspending brackets were bolted tension and compression-resistant to the upper wooden plank (H422-0730, 8 x 40) and the cross bar of the wall (H422-0220, 4 x 4.8 x 19) at a distance of $e = 1.0$ m. Image 1 shows this type of design.

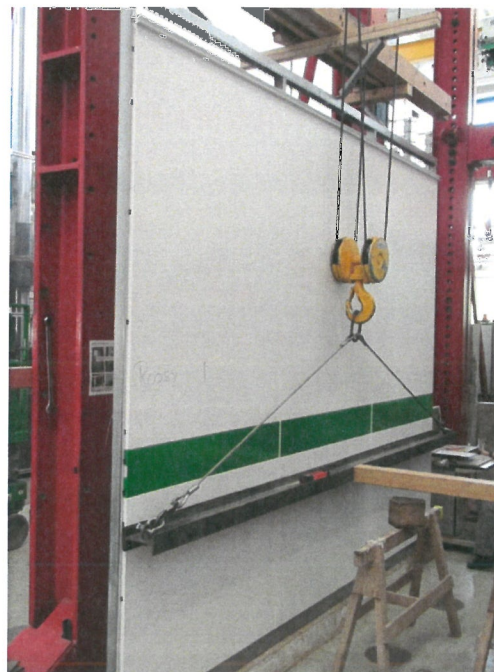
Image 2: Front view of the partition wall, the panel height of the wall is $h = 3.00$ m

The vertical steel sections had a length of $L = 3.20$ m. At this height, angles were used to bolt the cross bar to the vertical sections (hexagon drill screws, H422-0220, 4.8x19). The panelling had a maximum height of $h_{\text{Wall}} = 3.00$ m. In addition, a horizontal steel ceiling rail (H101-0008 01, $t = 3$ mm) was mounted at the upper edge in order to finish the panelling. A drill screw (H422-0220, 4.8x19) was used to connect the rail with the vertical sections. Image 2 illustrates the setup.

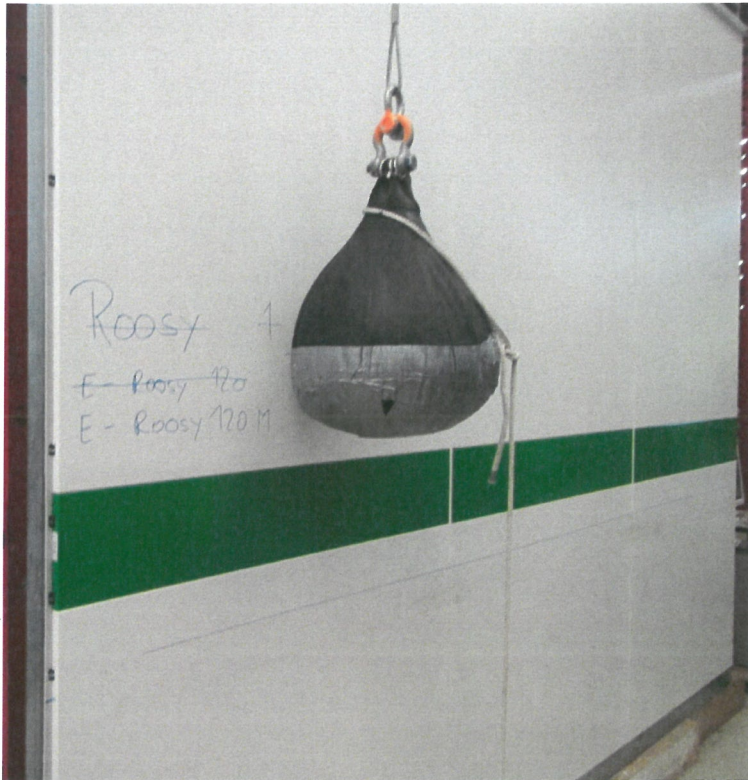
Image 4: Test setup of the partition wall for the pendulum impact test, $h = 1.50$ m

Image 4 shows the test setup. After the experiment, the wall structure was subject to a close visual inspection for damage. The test was repeated twice according to ETAG 003 using a pendulum energy of $E_{\text{Test}} = 120$ Nm.
